The Impact of Natural Fibers on Thermal Resistance and Spalling in High-performance Concrete

Abstract

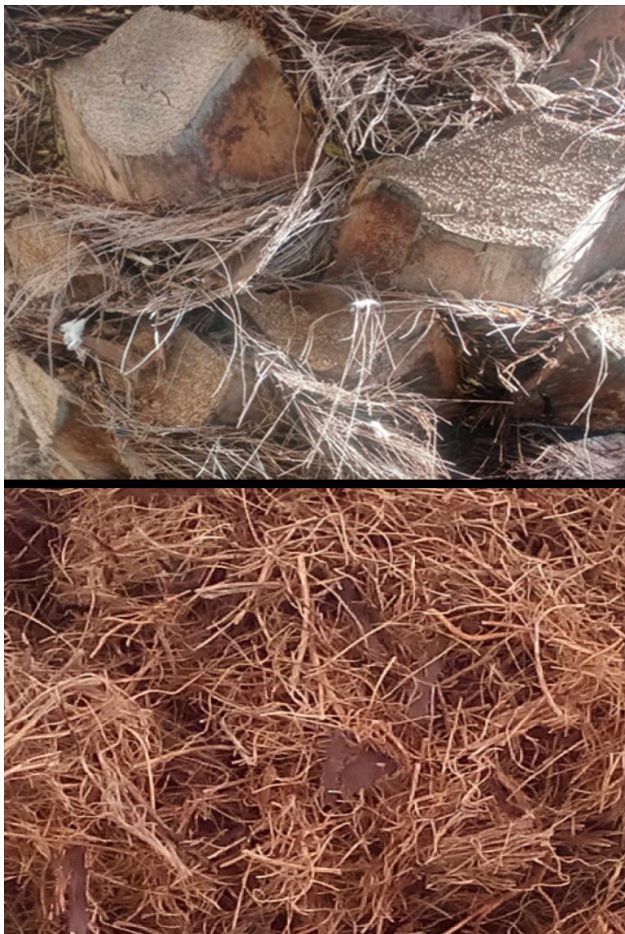
In this investigation, the focus was on fibers of the Dokar variety, sourced from the date palm plant, as depicted in Fig. 1. Drawing from the research conducted by Kriker et al. [30], which examined four types of fibers harvested from the exteriors of the date palm varieties Dokar,

Fig. 1 Illustrations of palm fibers

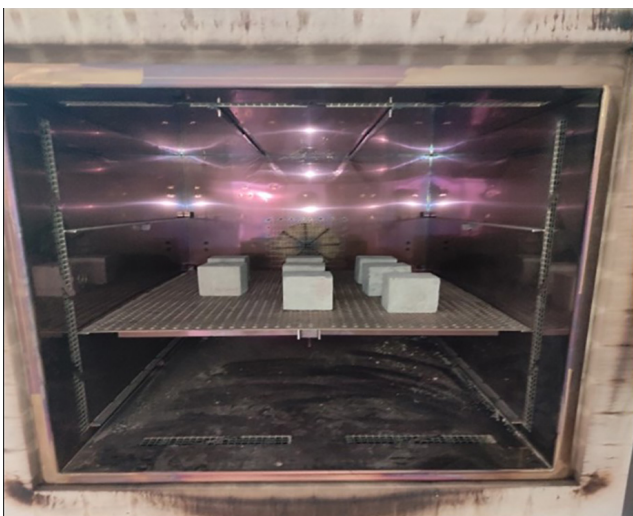
Fig. 3 Naberthen furnace

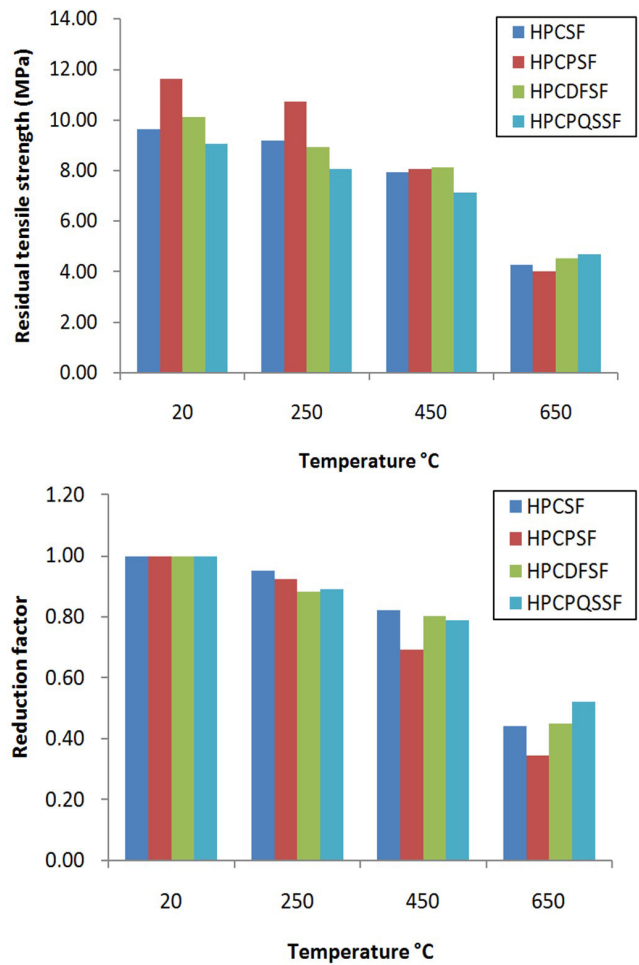
Fig. 7 clearly illustrates a continuous and linear drop in flexural strength up to 450 °C for all concrete samples. The curves describe the change in residual tensile strength as a function of temperature for various kinds of concrete. However, a notable loss in strength is shown in every instance as the temperature above this 450 °C threshold. In particular, concrete that incorporates palm fibers shows a relatively acceptable flexural strength compared to other types of concrete, exhibiting only a 55%

Fig. 7 Residual tensile strength of all concrete types as a function of temperature

reduction, similar to the outcome observed with polypropylene-based concrete.

This result arises from the ductile nature of the internal structure of these fibers, which enhances the flexibility of the concrete and prevents the formation of cracks, thus improving its flexural resistance [27, 36, 37].

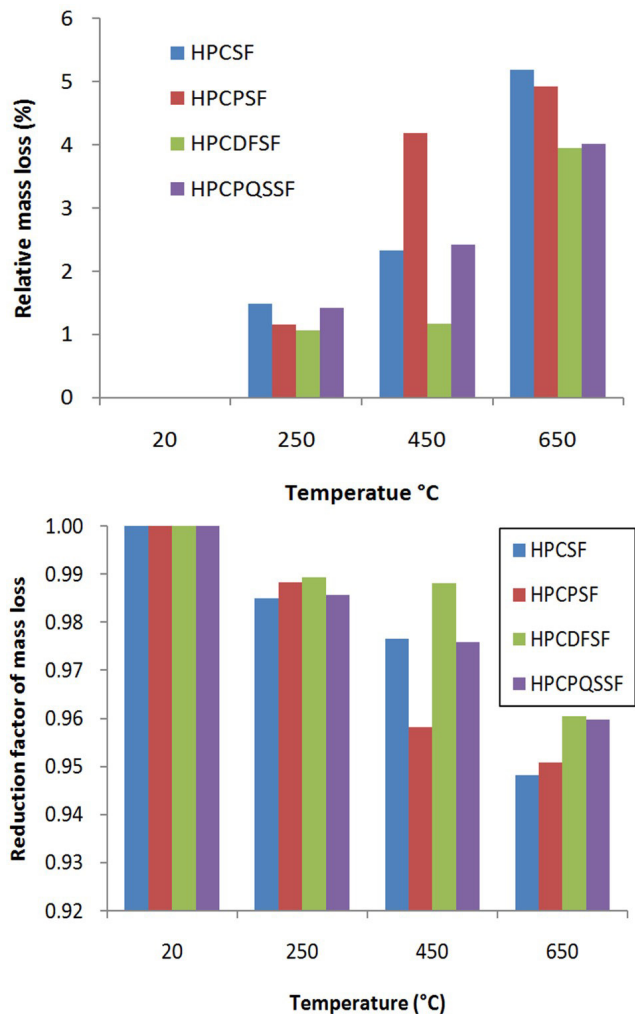
To assess mass loss, we measured the weight of the cubic samples before and after their exposure to elevated temperatures, as shown in Fig. 11. This representation highlights how the increase of temperature influences the reduction of the concrete mass samples. The correlation between variation in mass loss and temperature is clear for all four types of concrete examined, as noted by several authors [37–39]. They found that the variation in mass loss as a function of temperature exposure is linked to the presence of water in the concrete in free, bound, or adsorbed form, which gradually escapes and represents the main cause of the loss of concrete mass. These authors identified three phases in the evolution of mass loss.

- In the first phase, from room temperature to 150 °C, a slight loss of approximately 3% was observed, corresponding to the release of water contained in the capillary pores.
- Between 150 and 300 °C, a significant increase in mass loss is observed.
- Above 300 °C, a slowdown in mass loss is observed. The main physicochemical transformation undergone by the heated concrete between 150 and 300 °C is the dehydration of CSH.

Fig. 11 Residual mass loss as a function of temperature

However, all concrete samples examined in the present study exhibited a significant mass loss from room temperature to 650 °C. At 250 °C, the samples (HPCSF, HPCPSF, HPCDFSF, and HPCPQSSF) recorded a mass loss of approximately 3%, 5%, 7% and 10%, respectively. This trend continues with increasing temperature, reaching approximately 3%, 5%, 7%, and 10% at 450 °C. On the contrary, mix having palm fibers experiences minimal mass loss between 250 °C and 450 °C, unlike other types of concrete. This difference can be attributed to the fact that palm fibers only melt at very high temperatures, around 1170 °C [40], thus preserving their internal structure and improving the properties of this type of concrete. Above 600 °C, a significant increase in the rate of mass loss is observed. According to research conducted by Xiao et al. [40] and Zhang [41], the phenomena of splitting or degradation of the concrete surface may be linked to many reasons, including the breakdown of limestone particles and CO₂ emissions. When compared to other mixes, HPCDFSF mixes exhibit comparatively less mass loss, but HPCSF mixes exhibit a more noticeable mass loss than the others. The HPCDFSF and HPCPQSSF blends showed a mass loss of 3.95% at 650 °C, but the HPCSF and HPCPSF blends showed a mass loss of 5.02% at that temperature.
